EUROPEAN CENTRE ON PREVENTION AND
FORECASTING OF EARTHQUAKES (ECPFE)

EARTHQUAKE PLANNING AND PROTECTION ORGANISATION (EPPO)
MINISTRY OF ENVIRONMENT AND PUBLIC WORKS

TECHNICAL HANDBOOK for
SEARCH & RESCUE OPERATIONS
IN EARTHQUAKES

ATHENS, 1999
2nd EDITION

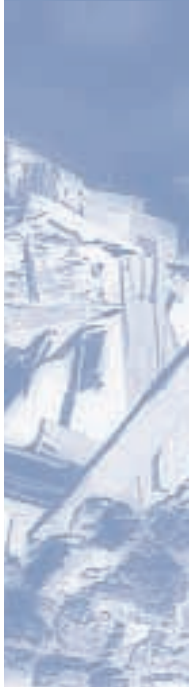
Photo 1: Beams and columns of the basement. Geometry is maintained even though six floors have totally collapsed above them. Apart from a survival space there is also enough space for a vertical ascending penetration to be undertaken. (Investigation work, Loutraki 1981)

It is performed after an horizontal penetration in some lower floor or in the basement of the ruin. (Figure 3, page 44, Photo 1, page 34, and Photo 13, page 40).

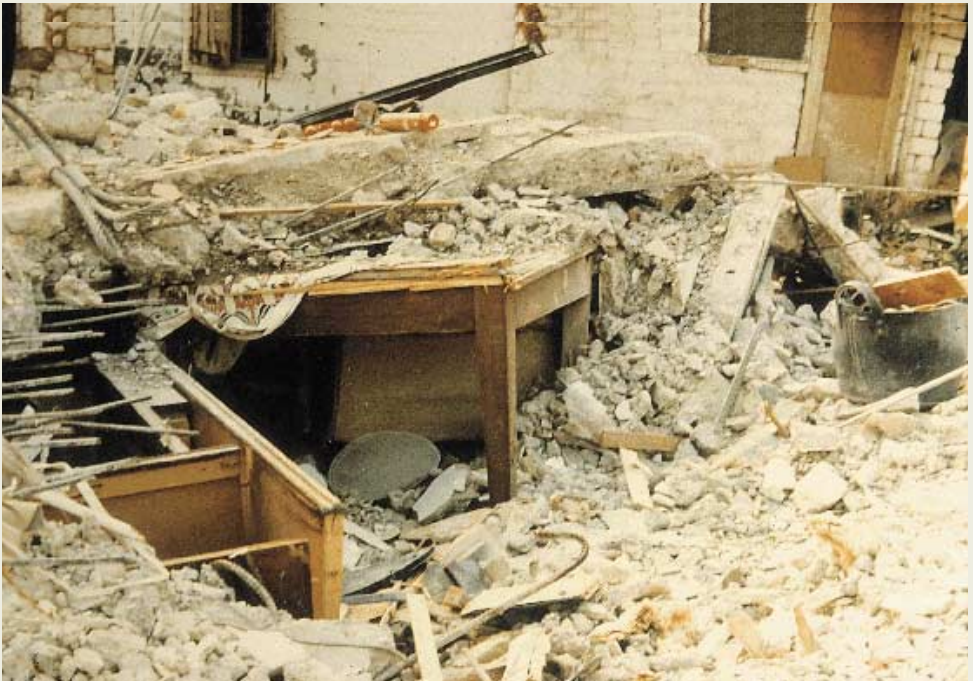
Photo 2: The table, apart from some slight damages on the upper part, has maintained its geometry and underneath there is space void of construction materials. Ideal shelter during an earthquake. (Kalamata 1986)

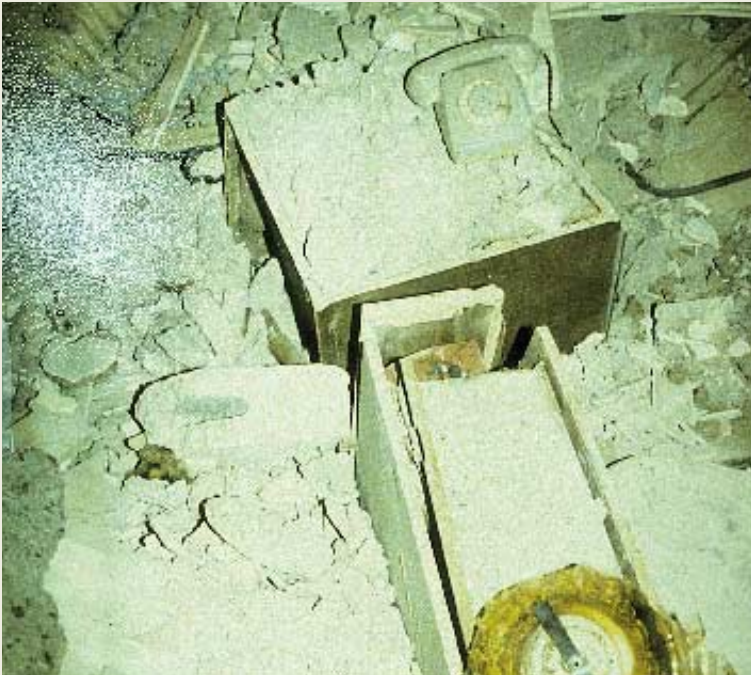
Photo 3: Furnishing of a bedroom as it was revealed after lifting the slab of the upper floor.

The bed side table and the top of the bed have been damaged from the falling bricks and lime plaster but their original height has been maintained. The benefit of the guide-line of covering a person in prone position under a firm furniture is self evident.

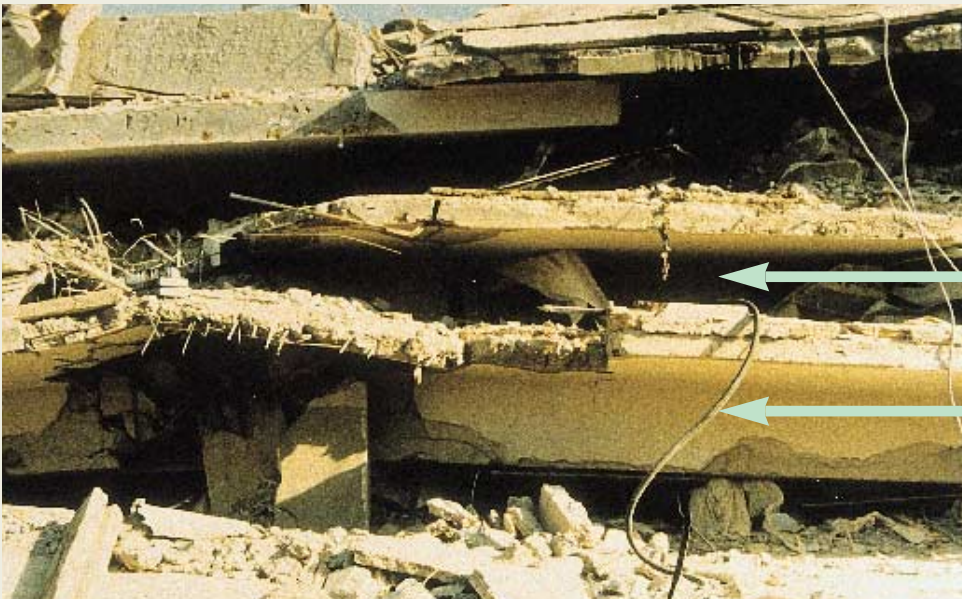
BEAM A

BEAM B

At the second phase, action is progressing in the place of interest (horizontal penetration).
(Rescue Operation, Kalamata 1986)

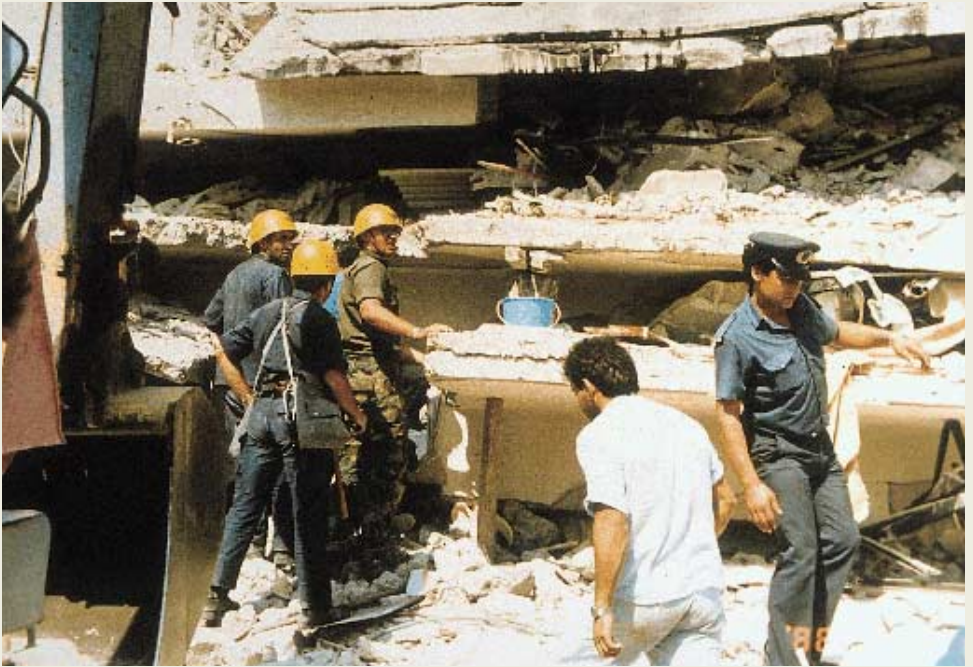
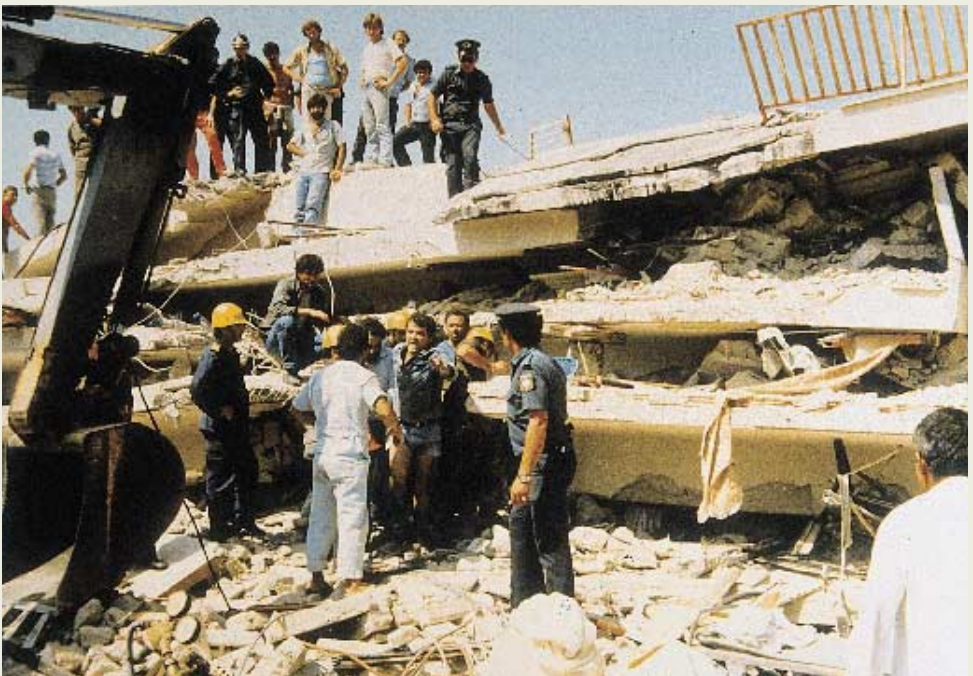
Photo 5-6: The first stage of the operation is in progress; cutting a part of a R.C. beam and slab of the floor under investigation. Contact with a trapped person located 3 ~ 4m away from the facade. During the second stage, horizontal penetration was applied. Furniture and walling material had to be splitted and removed in order to reach the trapped person. Duration of the operation 3 ~ 3.5 hours. (Rescue Operation, Kalamata 1986)

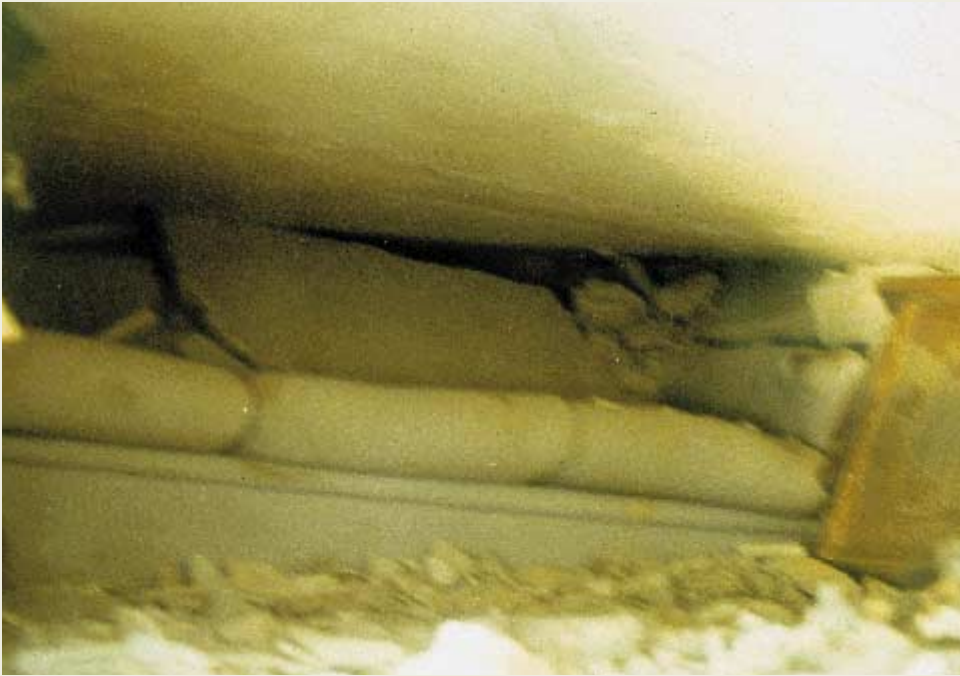
Photo 7: Survival space and the sofa where the trapped person was lying and rescued without injuries 16 hours after the earthquake.

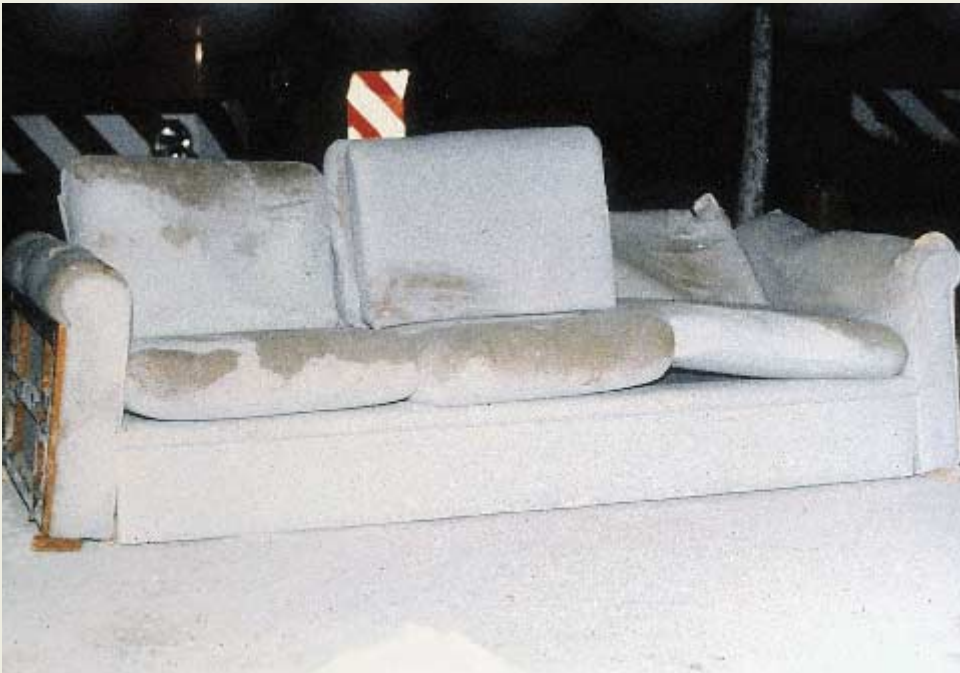
Photo 8: The same sofa in open space. It is rather obvious that only a part of the sofa was compressed and deformed due to the building's collapse. (Rescue Operation, Kalamata 1986)

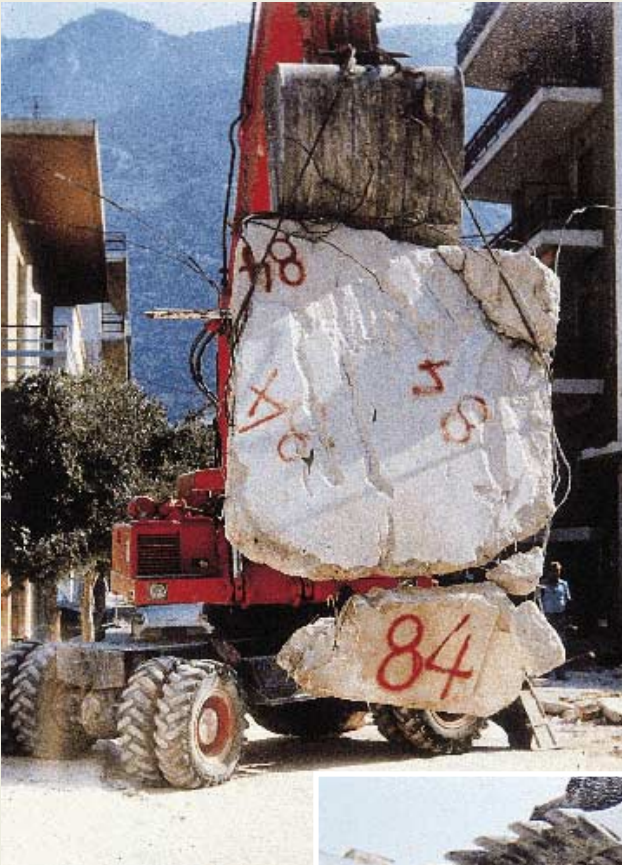
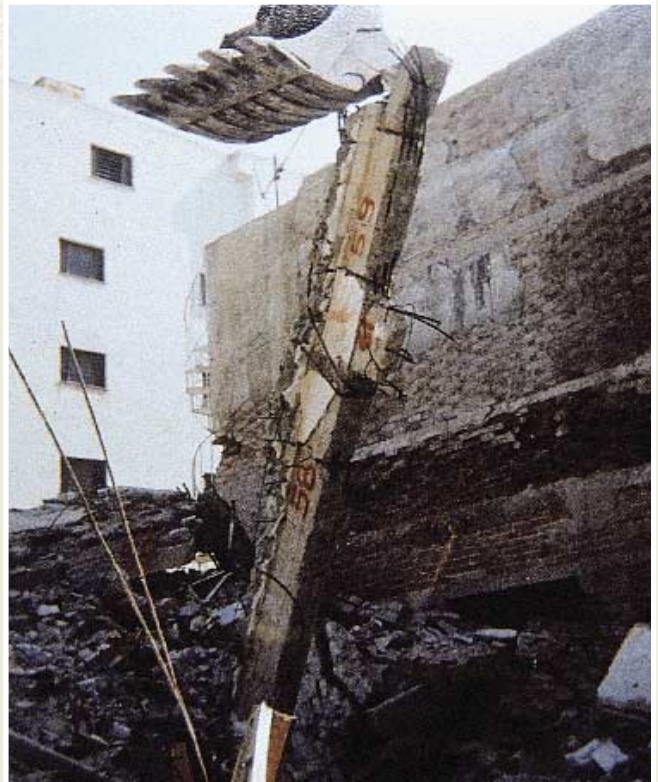
Photo 9-10:
Elevation of a slab (photo 9)
and a beam element (photo
10) by a shovel excavator.
Eccentric fastening so that the
main reinforcement takes a
vertical direction and therefore
the folding of the element is
avoided. (Investigation work,
Loutraki 1981)

Both of these two techniques aim to reduce the acting bending moments as to minimize the possibility of the folding of the structural element. (Photo 9,10,11 page 38-39). To secure the fastening, the secondary steel bars along the long side can be cut. For greater safety, wooden elements (frames from doors or windows etc.) or iron bars should be placed between the concrete and the wire rope, because during the collapse the concrete of the slabs is intensely disorganized, and therefore its compression strength is reduced. Finally, the steel bars are cut and the element is removed. The cut of the steel bars must be done right at the edge of the concrete or else there is high risk of injuries. Afterwards all material that lies between the penetrated and the next slab is removed and the operation continues in the same way.

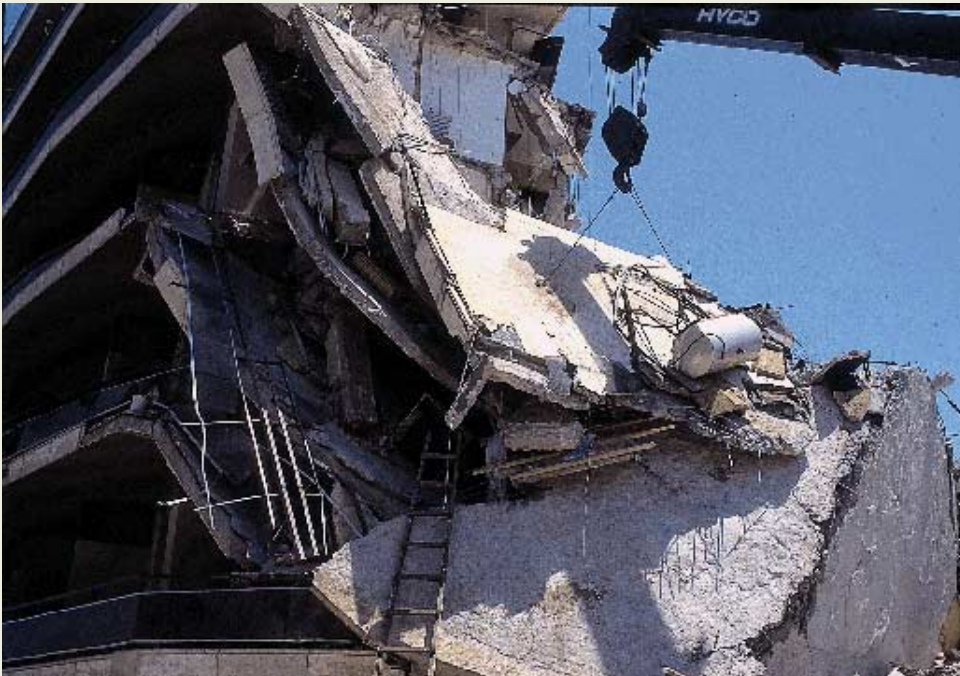
Photo 11: Lifting by using a crane, a big part of a slab that had a steep inclination because of the building's partial collapse. Cutting off this part from the rest of the slab by cutting the reinforcement across the fracture lines of the slab. (Aegio 1995)

The way to conduct the operation is almost exclusively determined by the risk deriving from half-collapsed buildings, and can be found in many forms and shapes (Photo 11, page 39). Therefore, a short level headed inspection is demanded for finding the risks. After that, a decision must be made on the way the operation will be conducted. It is obvious from the above, that the operation is much more complicated than the one for buildings that have suffered a total collapse. Nevertheless, there are some **general principles** that must be taken into consideration in such cases.

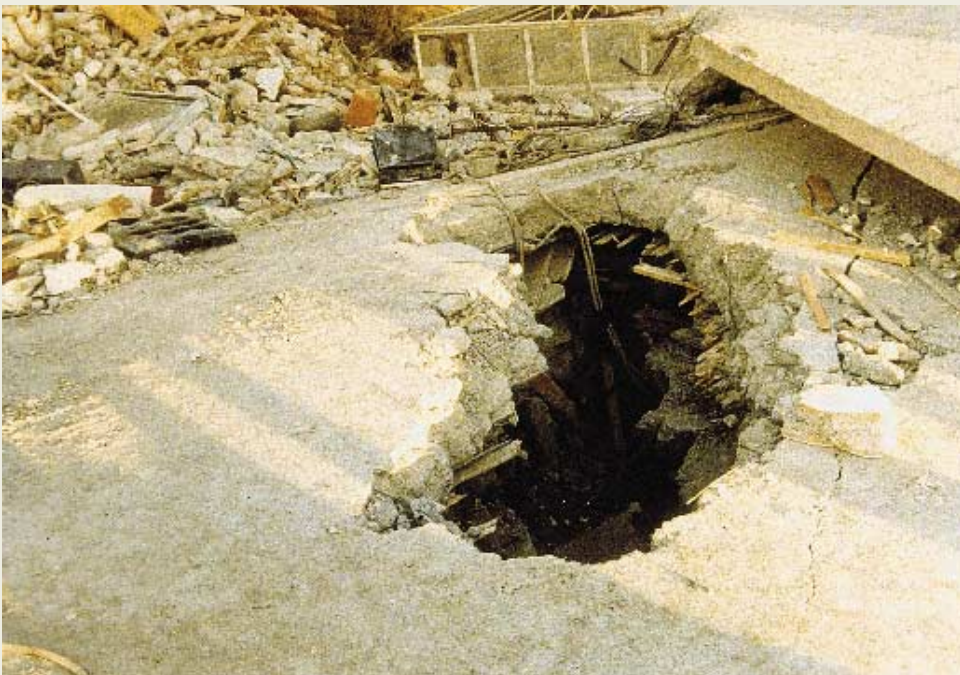
Photo 12: Starting point of a descending penetration on a location where the slab has rather low inclination, in contrast to the left side where the inclination of the slab is steeper. Two slabs were penetrated and horizontal penetration followed, downwards to the point that the arrow indicates. An infant was rescued 24 hours after the earthquake. (Rescue Operation, Kalamata 1986)

In Figure 2 (page 43) a descending penetration is presented. In Photo 12 (page 39) a slab, as it was penetrated for a descending penetration application for a rescue operation, is shown.

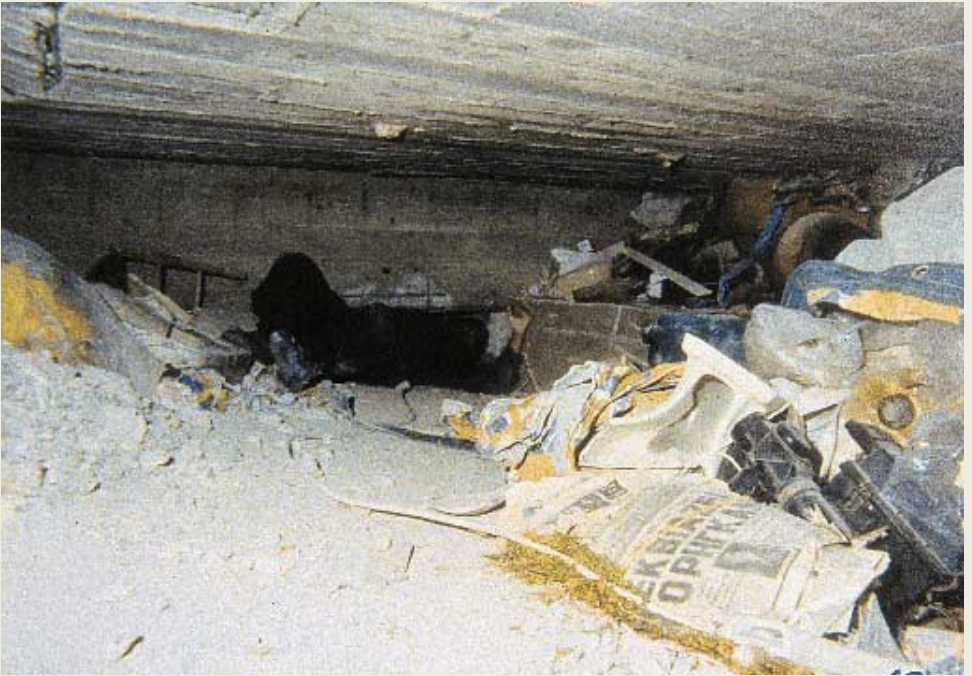
Photo 13: *Pilots of a building that has totally collapsed. Even though there is a lack of walls, there is enough space not only for survival but also to start an 'ascending penetration'. (Training in Ruins, Kalamata 1986)*

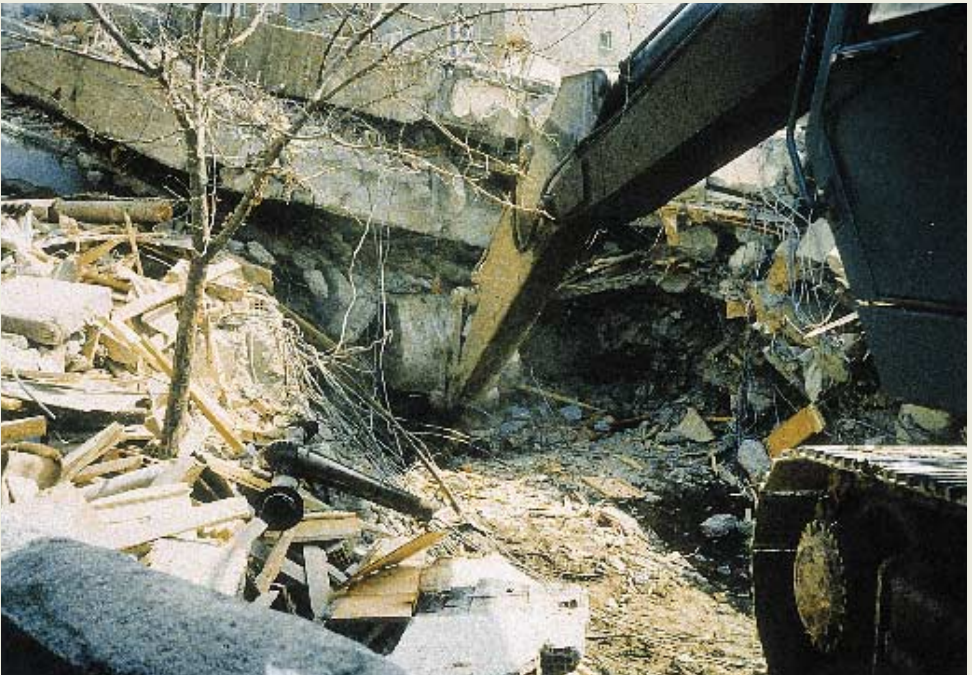
Photo 14: *Creating a wide penetration front by removing all materials from the facade of the building. (Frontal Penetration)*

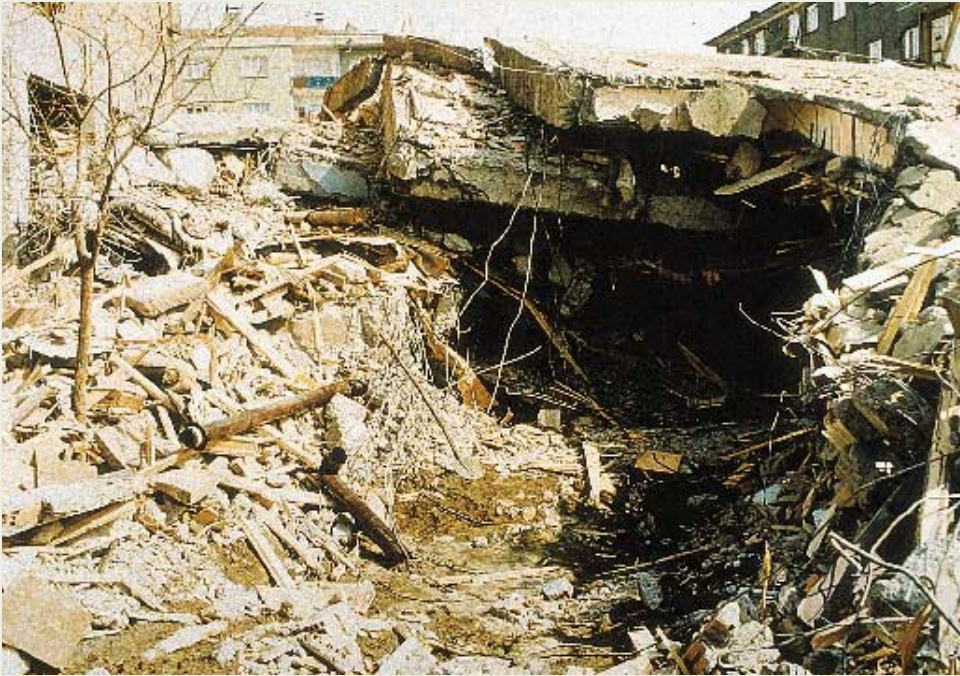
Photo 15: Creating a wide penetration front by removing all materials from the facade of the building. (Frontal Penetration)

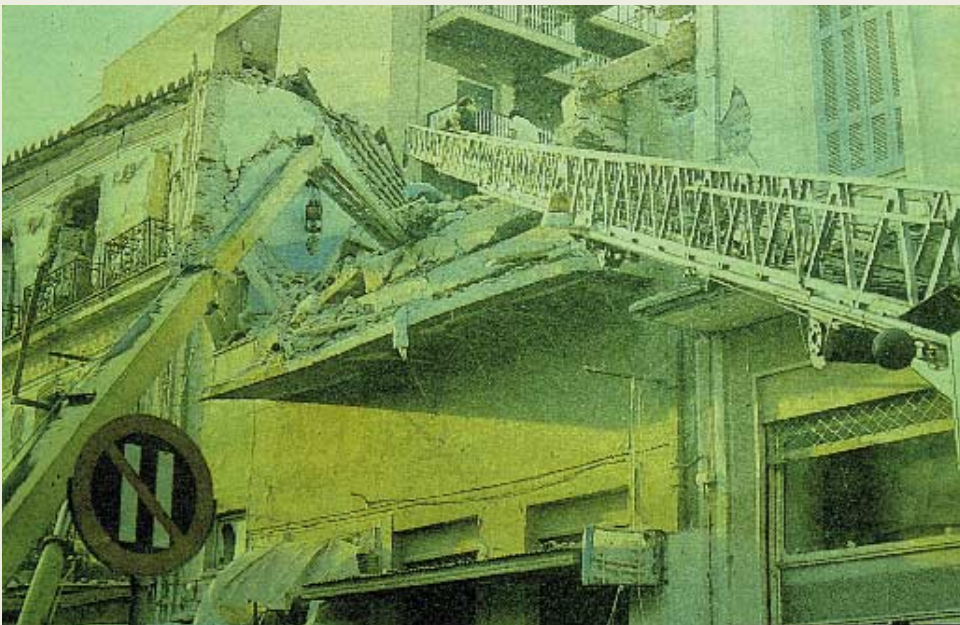
Photo 16: Rescue of trapped persons from a three-storey building of which only the two upper floors collapsed. The risk for the trapped and the rescuers is obvious in case of a possible collapse of the ground floor during a strong aftershock. The crane arm on the left side aims at preventing the collapse of the wall of the near-by building towards the rescue operation front. (Rescue Operation, Kalamata 1986)

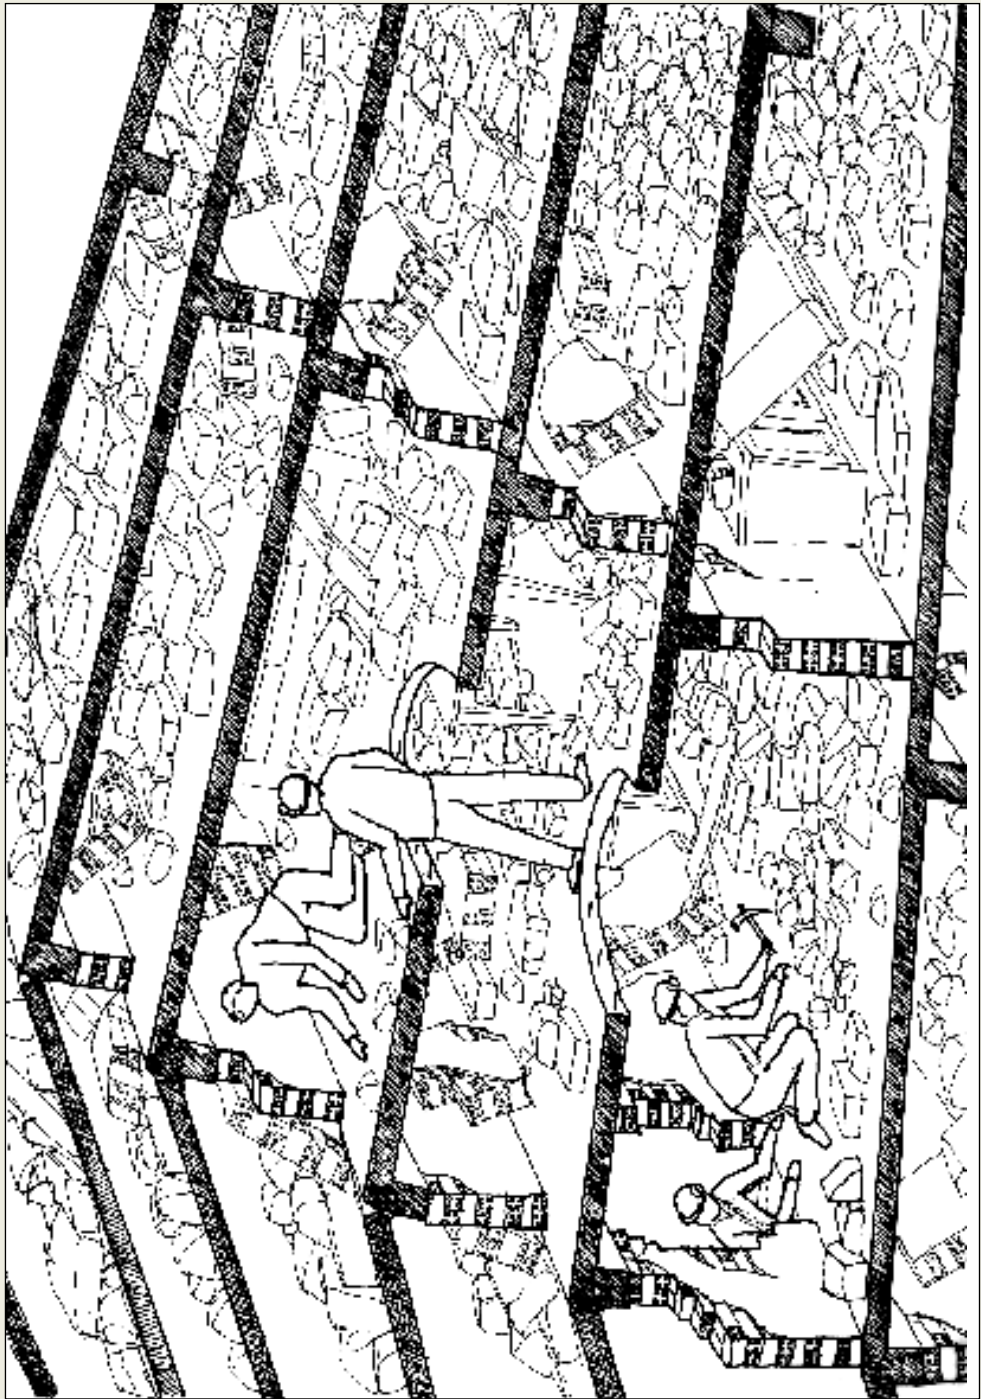
Figure 3. Ascending Penetration
